CONSTRUCTION
CANADA

BUILDING WITH MASONRY

Restoration of a Heritage Brick Clock Tower

Meeting the National Energy Code Requirements with Masonry

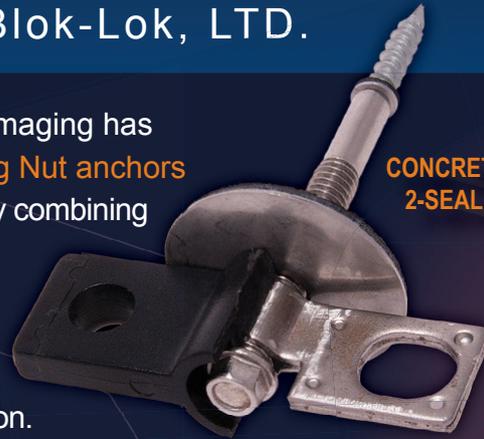
CONCRETE THERMAL
2-SEAL™ WING NUT

Rigorous independent testing with 2D & 3D thermal imaging has proven that the **Thermal 2-Seal™ Tie & Thermal Wing Nut anchors** are the most efficient anchors on the market today. By combining innovative design with state-of-the-art materials, heat transfer and moisture infiltration are greatly reduced in today's wide cavity construction.

- UL-94 coating creates a thermal break at the insulation.
- Stainless Steel barrel transfers **one-seventh the thermal energy** of standard zinc barrels.
- The Thermal 2-Seal™ Anchors feature a dual-diameter barrel with EPDM washers making them the **ONLY*** anchors on the market to seal **BOTH** the insulation and the air barrier.
- **By using a steel reinforced wing, the Wing Nut version maintains integrity of the masonry veneer in the event of a fire. All-plastic wings melt, potentially causing structural failure.**
- Available with a standard or concrete tip to accommodate various masonry types.

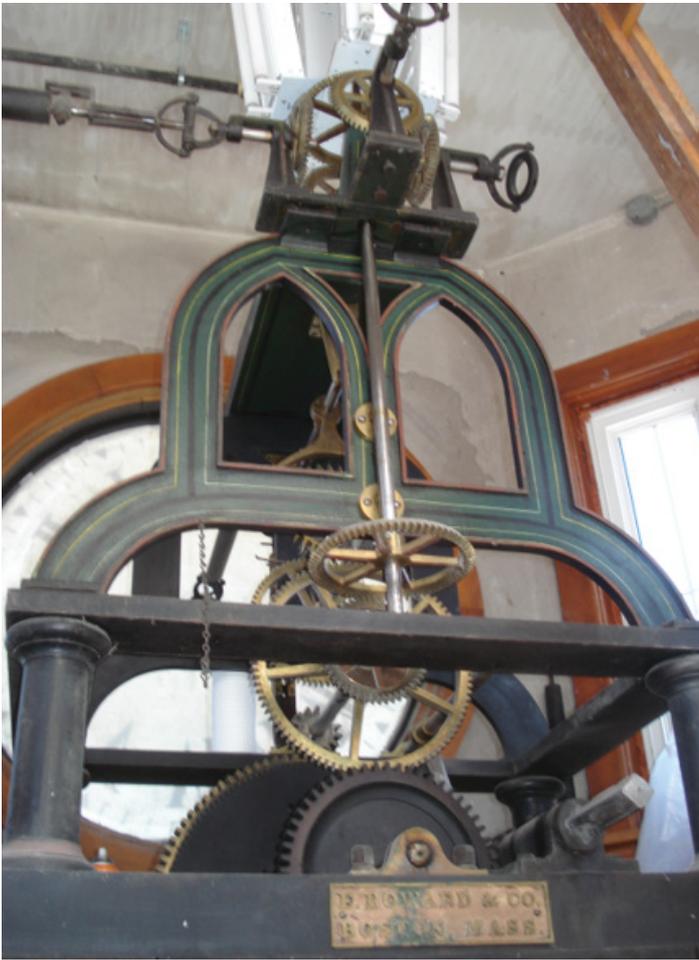
Figure 1

In 2011, the Town of Huntsville, Ont., decided to address the water-damaged, wood-floor framing supporting the clock tower motor and gear mechanism at the Town Hall.

The Town of Huntsville retained a structural engineering consultant in September 2011 to prepare a repair scope of work to address the water-damaged, wood-floor framing supporting the clock tower motor and gear mechanism (Figure 1, page 6). The author was not involved with the project then. The repair work was

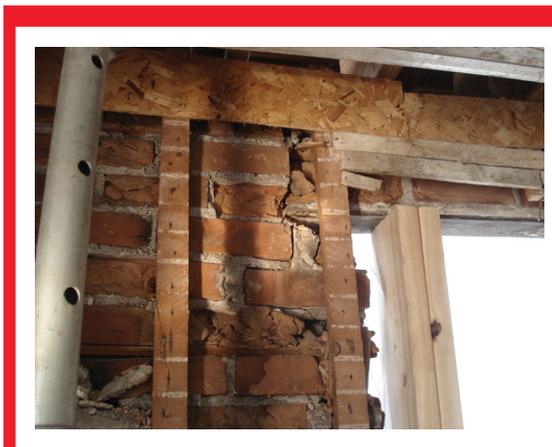
Figure 2

The two loadbearing walls of the clock tower had deteriorated severely.

On September 17, 2013, a detailed assessment of the brick walls was completed. The deterioration noted previously was found to be prevalent throughout the exposed structure. The damage to the brick masonry was most severe at the two loadbearing walls (Figure 2). The interior wythe was no longer significantly contributing to the structural integrity of the walls. Damage was noted to be most extensive at the top of the masonry wall. The condition improved nearer to the building's main roof. It was decided the condition of the brick masonry walls posed a life-safety risk and had to be repaired immediately.

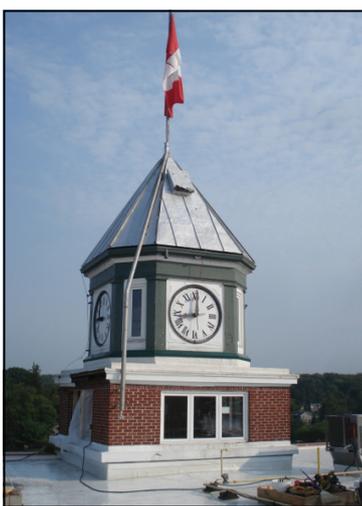
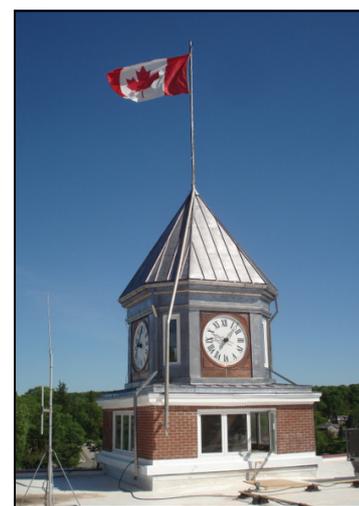
The original tower and the restored structure (right).

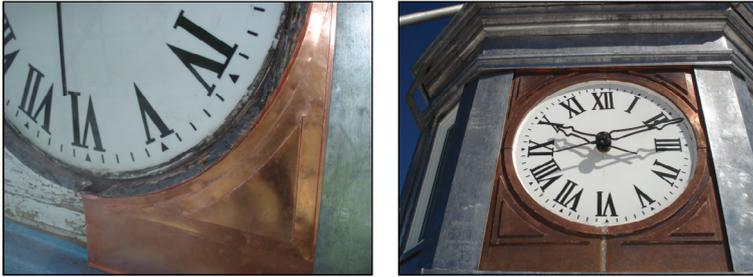
Copper recladding is underway. The image on the right shows the tower after recladding was complete.

- remove existing rotted material and replace/consolidate as required;
 - install new waterproofing membrane over the exterior surface;
 - repair exterior wood sheathing of clock tower;
 - reclad the structure with copper and lead-coated copper to match existing profiles;
 - replace standing-seam steel roofing with lead-coated copper standing seam; and
 - add a code-compliant lightning protection system.
- The wood cladding required seasonal sanding and painting to mitigate the infiltration of water. The proposed metal cladding system would eliminate the need for seasonal maintenance.

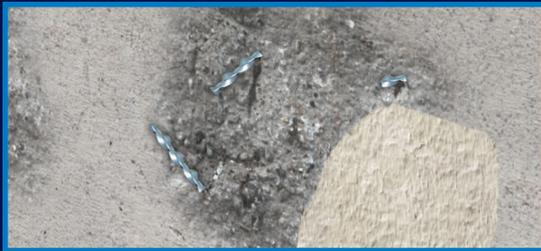
PATCH-LOK Helical Patch Reinforcement

Designed to provide a powerful mechanical key between damaged substrate and patching compound in spalled concrete. Patch-Lok is also effective wherever a strong, non-chemical bond is required. It reduces the need to build patch up to required profile and includes all required drill bits and installation tools.

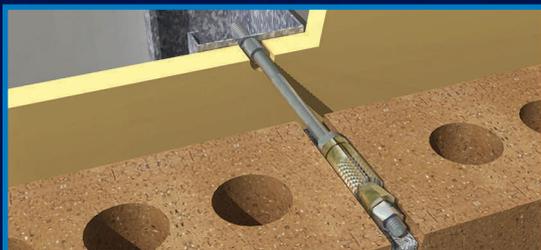
TORQ-LOK® Mechanical Restoration System

An easy to use, cost-effective method for reconnecting existing veneer to various substrates. Manufactured from stainless steel and brass for a corrosion-resistant tie assembly. Use around bulging areas or sections that are to be removed; such as replacing cracked headers in composite walls.

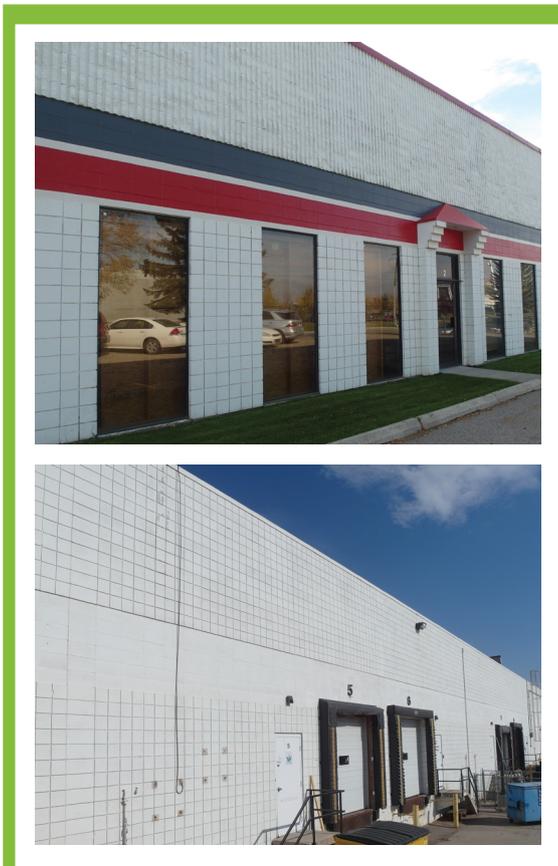
Figure 6

The elevations of a typical Calgary warehouse.

On Elevation I, the fenestration wall ratio is 0.180 (i.e. 18 per cent); on Elevation II, even with the large bay doors and man doors, the FDWR is only 0.101 (i.e. 10.1 per cent). Assuming the typical RSI value of 2.64 (R-15) for insulated metal man doors, and 0.405 (R-2.3) for the large bay doors and glass windows and doors, yields RSI requirements of 1.90 and 1.29 (R-10.8 and R-7.3) for Elevation I and Elevation II, respectively.

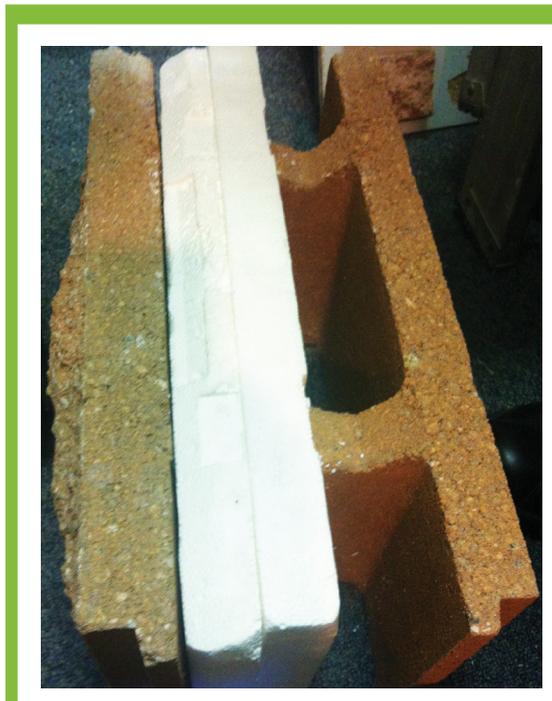
Figure 8

An insulated concrete masonry unit with two face shells.

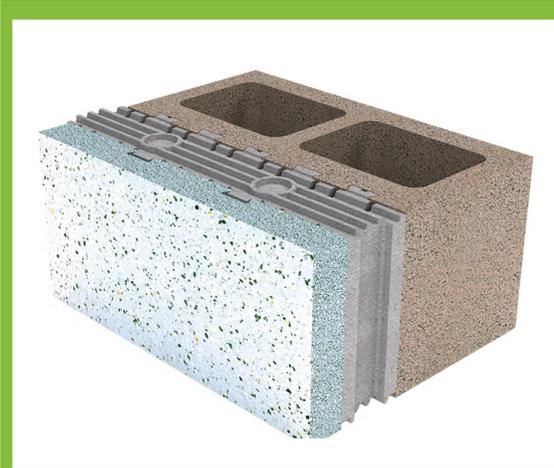
Figure 9

An insulated concrete masonry unit with three face shells.

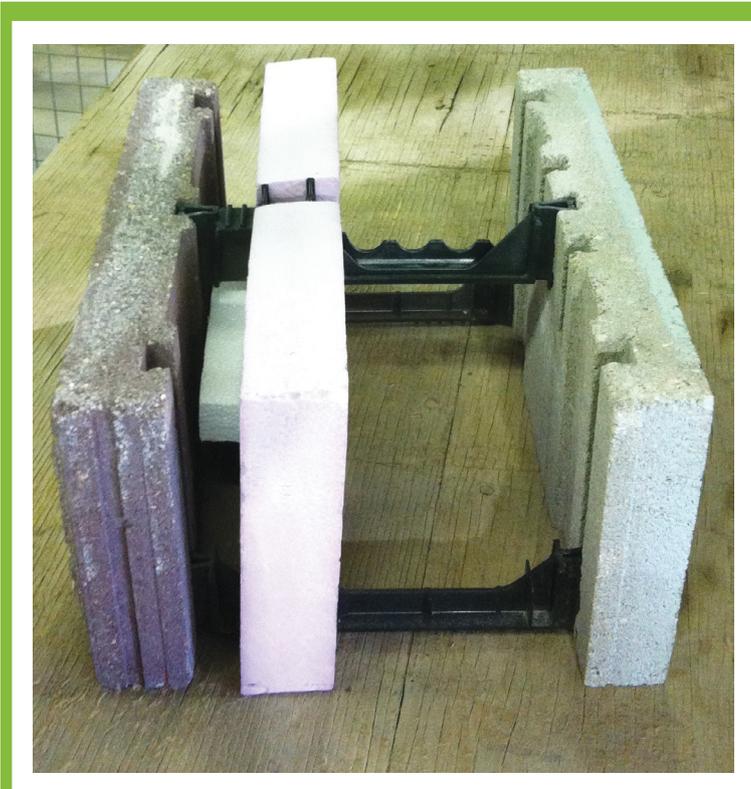
Figure 10

An insulated concrete masonry form (ICMF).

masonry unit shell faces. However, unlike ICF, these concrete masonry units are still laid like a traditional concrete block wall and then filled with concrete (Figure 10). Thus, the system is essentially a fully grouted concrete wall, but without the web interference. These concrete masonry products have units that are typically 310 mm (12 1/4-in.) thick, with 50 mm (2 in.) of XPS insulation embedded into the unit at the time of manufacture.

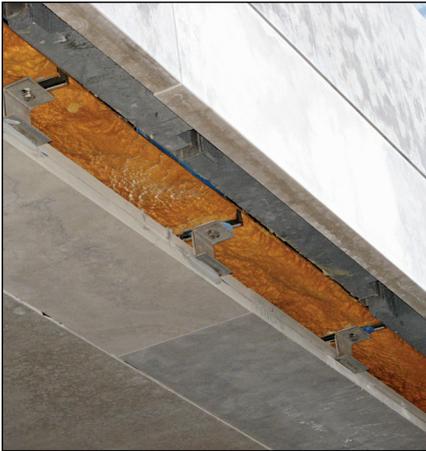
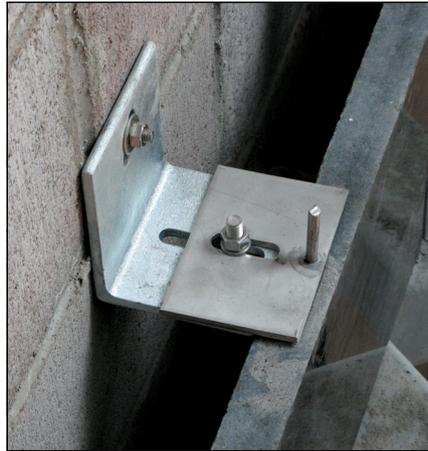
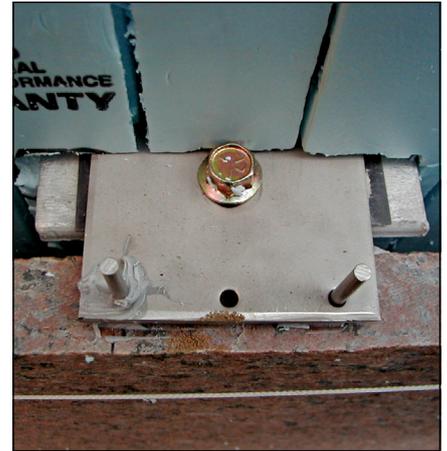
For natural stone, there are many new proprietary anchoring systems, some of which are back-anchored into the stone to allow for an open-joint rainscreen design. Examples include (from left to right): soffit anchor on strut, and two-piece anchors without or with di-electric separation.

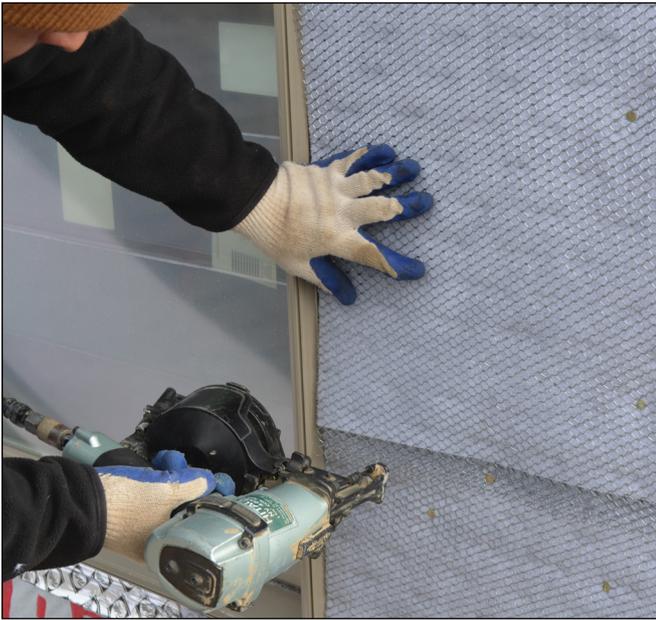
Factory-assembly metal lath and drainage plane systems install like regular lath.

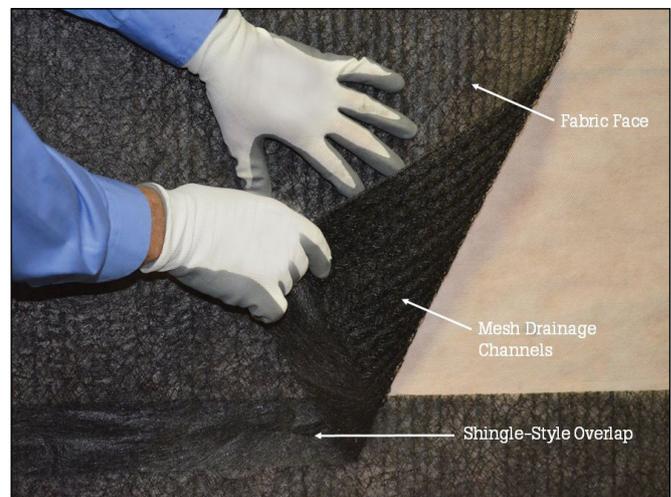
Drainage plane with factory-attached water- and vapour-permeable fabric.

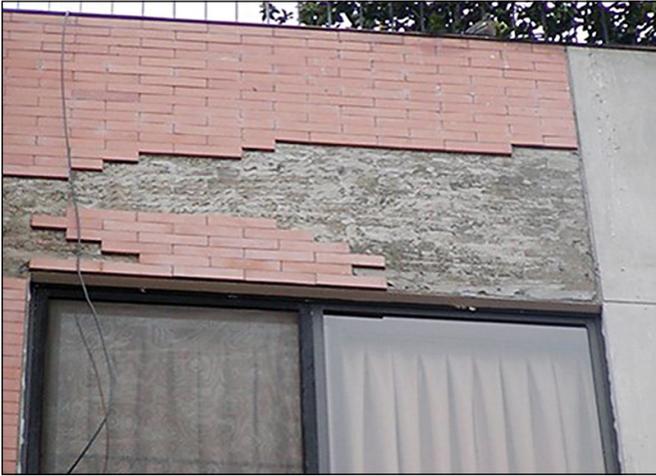
Thin-brick veneer popped off the substrate.

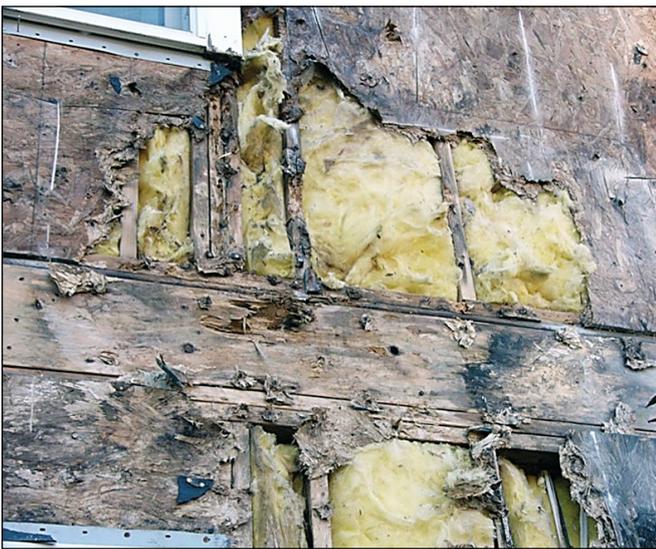
Mould and water damage resulting from a lack of drainage behind adhered masonry. One should note how the damage radiates from the bottom corner of the window, which is a typical location for leaks.
